CASE REPORT

Intrapelvic Protrusion of a Broken Guide Wire Fragment during Fixation of a Femoral Neck Fracture

Ahmadreza Afshar, MD

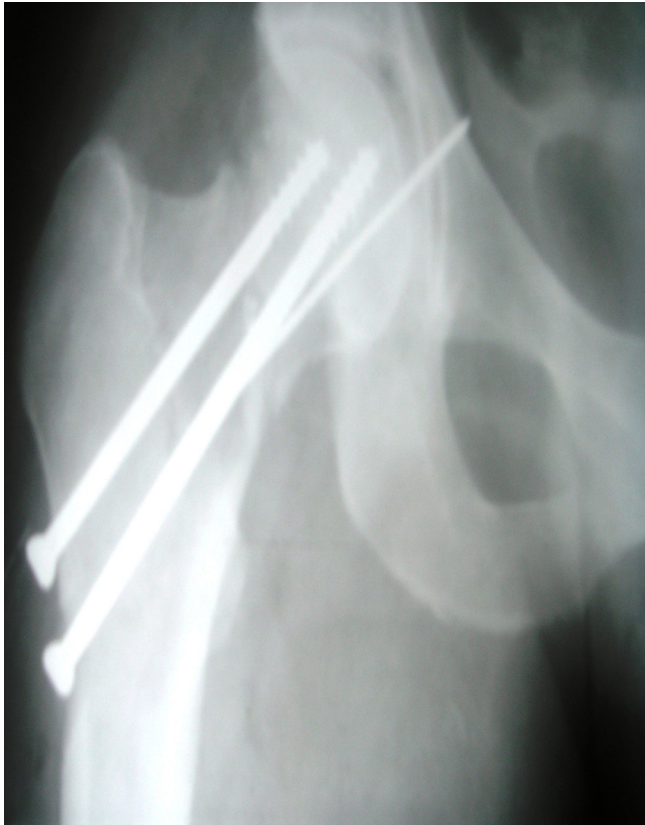
Figure 1. Internal oblique view of the right hemipelvis; X-ray shows the broken fragment of the guide wire that was passed through the hip joint and protruded into the pelvis.

were inserted into the femoral neck and advanced to the subchondral bone of the head. The bone had a hard quality. The wires were the first use. The two first screws were inserted after drilling with a cannulated drill bit. Frequent screening was carried out during the drilling and screw insertion. After drilling on the third guide wire, the image intensifier revealed that the guide wire was advanced into the pelvis. The drill bit was withdrawn and it was realized that the guide wire was broken and the distal fragment had migrated through the acetabulum into the pelvis. The other end of the broken wire was at the fracture site [Figure 1]. The broken fragment was situated 6 to 7 cm medial from the lateral femoral cortex. The breakage of the guide wire was not felt.

Through the ilioinguinal extraperitoneal approach the inner surface of the acetabulum was touched and the protruding tip of the wire was recognized. The wire was retrieved from the pelvis under direct vision with pliers.

When the pictures of the image intensifier were reviewed, it was realized that the third pin somehow was deflected when it was inserted. This happened because of the flexibility of the wire and the hard quality of the bone. When the drilling on the third guide wire was advancing, the guide wire was cut because of a diverging angle and the distal fragment jammed in the cannulated drill bit. As the drill bit advanced further the jammed broken distal fragment of the guide-wire was pushed through the

acetabulum into the pelvis.
