CASE REPORT

Fatal Cobalt Cardiomyopathy Following Revision Total Hip Arthroplasty – A Brief Report with Review of Literature

Research performed at All India Institute of Medical Sciences, New Delhi, India

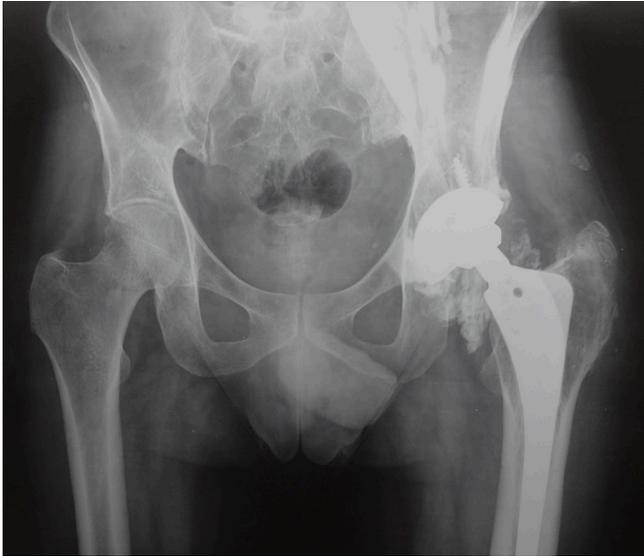
Figure 1. X-ray both hips with pelvis showing severe osteolysis and ill-defined increased radio opacities around the neck and periacetabular region of left prosthetic side extending upto the iliac region.

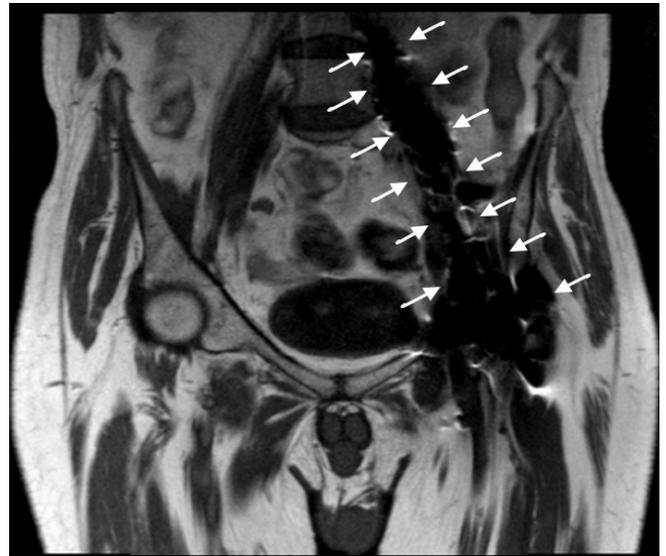
Figure 2. Magnetic Resonance Imaging (MRI) with Metal Artifact Reduction Sequence (MARS) showing periprosthetic collections around the neck of the femoral component and the surrounding soft tissues extending upto the iliopsoas muscle (white arrows).

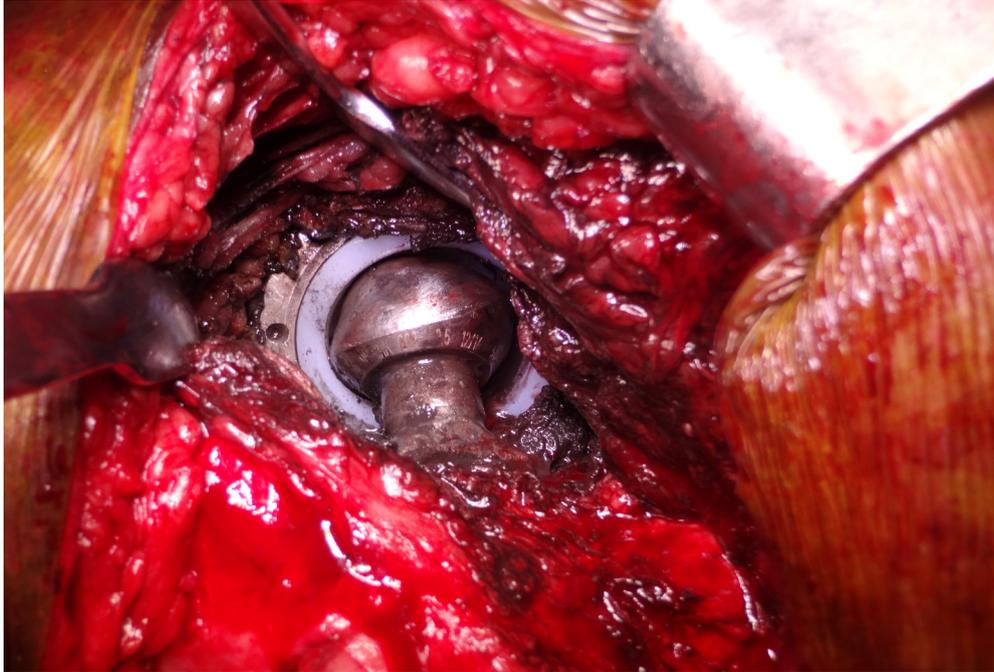
Figure 3. Intraoperative picture showing grossly distorted femoral head and the polyethylene liner. Note the black granular deposition in the surrounding soft tissue.

that the trunnion might have been damaged during the ceramic head fracture. As the revision surgery was done with a metal on polyethylene articulation, the damaged trunnion in turn eroded the metallic head leading to trunnionosis and hence the failure again. The deformed polyethylene liner and the metallic head in the second revision surgery also indicates eccentric loading over the articular surfaces leading to accelerated wear and hence failure.

Hence, we recommend the following points to be considered while revising a fractured ceramic component:

1. The fractured ceramic component should be revised with a ceramic component only (new generation) ensuring that the other risk factors for fracture such as component malpositioning, damaged trunnion etc. are not present.
2. The trunnion should be carefully examined and when in doubt about its damage, it should rather be revised during a revision for the fractured ceramic components.
3. Patients who have undergone Metal on Polyethylene revision for a ceramic fracture should be routinely followed up clinically and blood tests for serum Cobalt levels, especially if they have any symptoms.
