CASE REPORT

Modular Well-Fixed Hip Revision Stem Fracture:
A Case Report and Literature Review

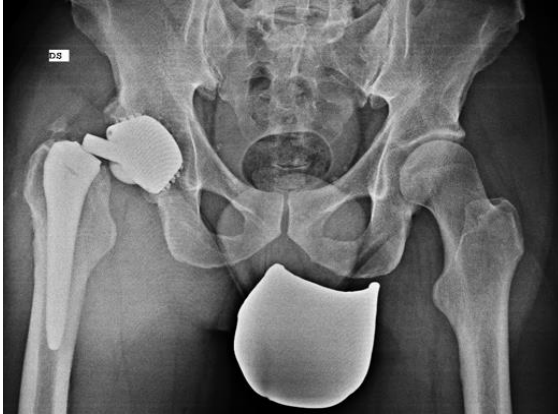
The initial prosthetic implantation was performed at another medical facility in 2006, and in 2011, the first fracture of the modular neck occurred, followed by the first prosthesis revision also performed at another hospital

Figure 1. Preliminary X-rays of the first prosthetic modular neck fracture (2011)

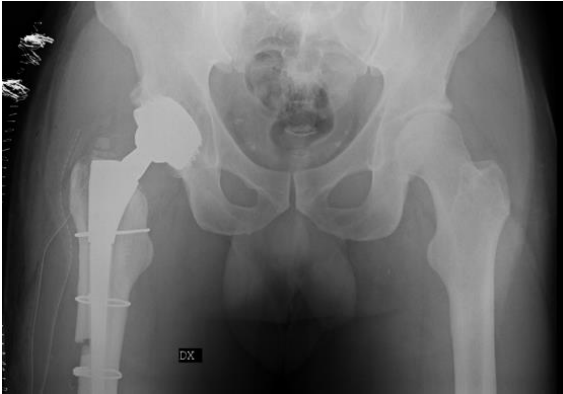
Figure 2. Post-operative X-rays of the first revision surgery (2011)

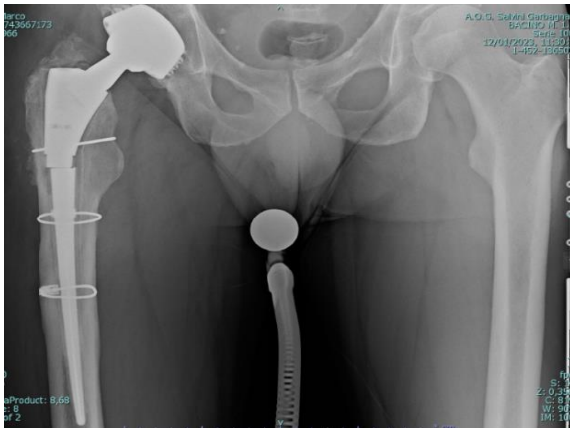
In January 2023, approximately one week following the onset of right hip pain without trauma, the patient arrived to our emergency department where new X-rays were performed, revealing a fracture of the prosthetic stem [Figure 3].

Figure 3. Preliminary X-rays of the second prosthetic modular stem fracture (2023)

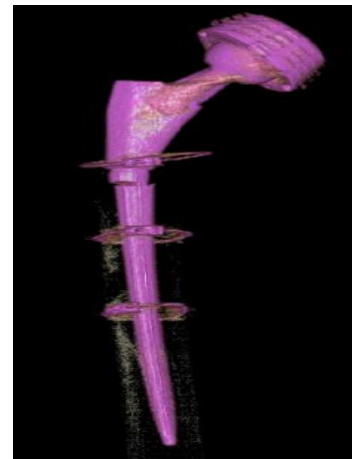
Figure 5. Preliminary CT-scan (3D reconstruction) of the second prosthetic modular stem fracture (2023)

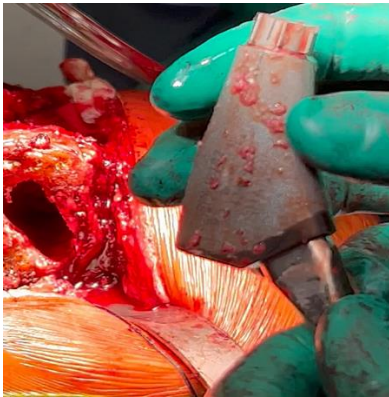
After the cleaning of the proximal portion of the greater trochanter, the prosthetic collar was exposed, noting its mobilization. It was then manually extracted, preserving the

Figure 6. Intraoperative image: extraction of the prosthetic collar

trochanteric region intact [Figure 6]. Subsequently, with a safety cerclage placed below the planned osteotomy point, an extended sub-trochanteric osteotomy was performed from the bottom of the first cerclage to the level of the isthmus. Sequential drilling was performed and subsequently joined by cutting with a blade along the posterior femoral region, laterally to the rough line, and the anterior femoral region [Figure 7]. After removing the bone flap, the prosthetic stem was exposed, detached, and extracted [Figure 8].

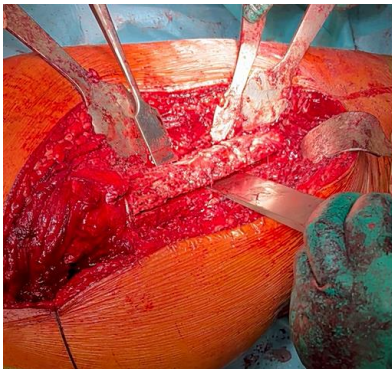
Figure 7. Intraoperative image: subtrochanteric osteotomy

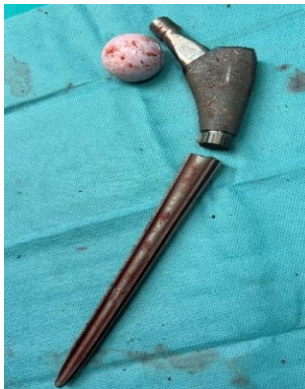
Figure 8. Intraoperative image: extraction of well-fixed stem

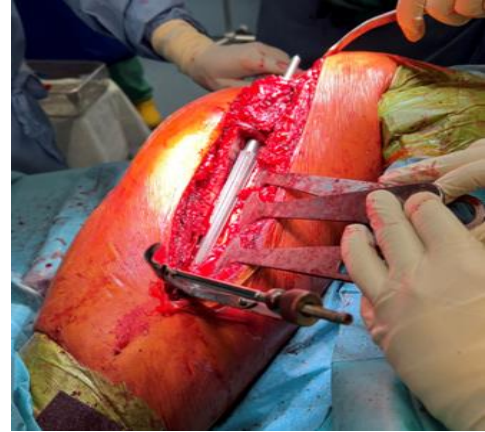
Figure 9. Intraoperative image: implantation of revision uncemented stem

Following meticulous canal debridement and the insertion of progressively larger broaches, a definitive uncemented stem was implanted with a lateralizing turret and ceramic head [Figure 9]. Finally, the bone flap was repositioned and fixed with 3 cable-ready cerclages [Figure 10].

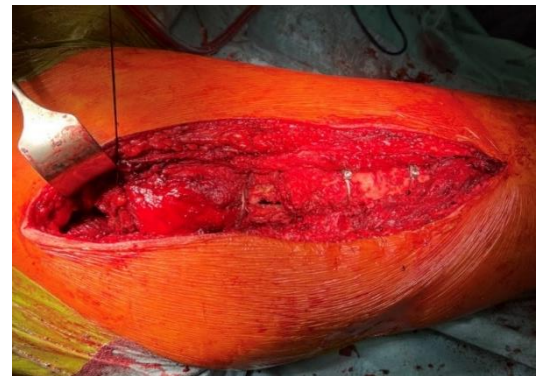
Figure 10. Intraoperative image: cable-ready cerclages

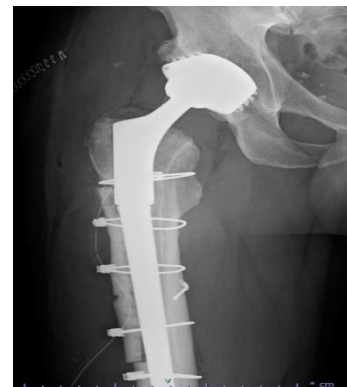
Figure 11. Post-operative x-rays: antero-posterior projection

After the surgery, postoperative follow-up X-rays were performed [Figure 11, 12].

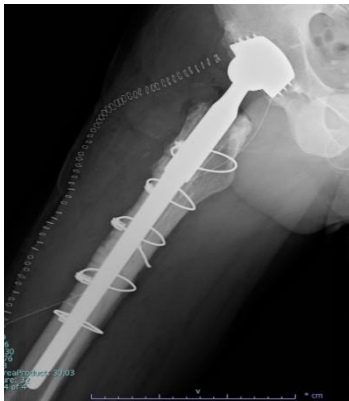
Figure 12. Post-operative X-rays: axial projection

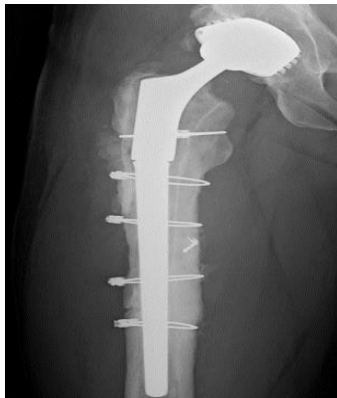
Figure 13. X-ray at 14 months: antero-posterior projection

In the last evaluation (14 months) no signs of complications were observed and the patient had an Harris Hip Score of 91, 5 [Figure 13-16].

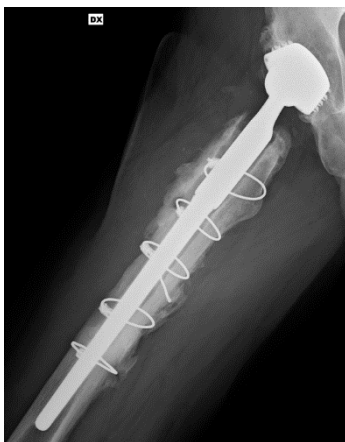
Figure 14. X-ray at 14 months: axial projection
