CASE REPORT**Stress Fracture of the Lateral Femoral Condyle after Total Knee Arthroplasty**

Mohammad M. Sarzaeem, MD; Mahmood Jabalameli, MD

*Research performed at Imam Hossein Hospital, Shahid Beheshti University of Medical Sciences (SBUMS), Tehran, Iran**Received: 31 May 2016**Accepted: 5 October 2016***Abstract****Background:** This is to assess one of the rare complications after total knee replacement and to assess risk factors of failure.**Methods:** 11 patients with varus knee and an average age of 67 years underwent TKA between 2005 and 2013. All patients returned with a sudden sharp knee pain, disability to walk and significant decrease in ROM about 4 to 8 weeks after surgery. Radiographic examination revealed a lateral femoral condylar stress fracture.**Results:** After analyzing the images, we found common characteristics among all patients, which might be attributable to the later fracture including varus deformity >25, femoral component lateralization, and valgus correction.**Conclusion:** Surgeons should be aware of the risk factors to consider before, during, and after surgery.**Keywords:** Lateral femoral condylar fracture, Osteoporosis, Severe varus deformity, St

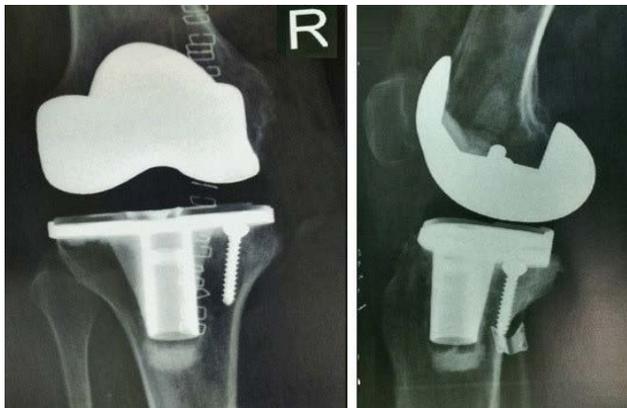
Figure 1. Post operative radiographs after a primary TKA.

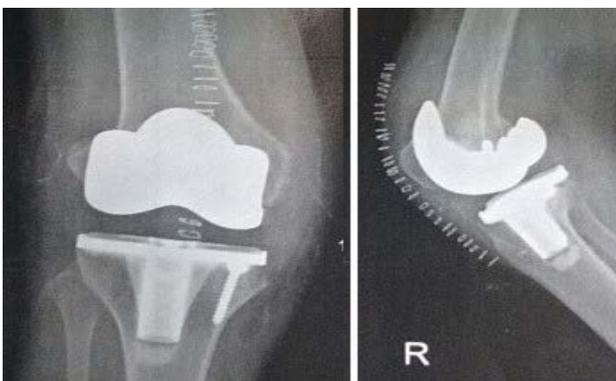
A 68-year-old woman, BMI=23, with 27° of varus deformity in the right knee and thrust on weight bearing underwent primary TKA [Figure 1]. Patient returned after 4 weeks with a sharp knee pain and inability to walk. Clinical examination of the collateral ligaments was unremarkable but severe lateral femoral condylar fracture was observed in radiographs [Figure 2].

Figure 2. Post operative radiographs 4 weeks after primary TKA. Condylar fracture is notable on the lateral side of the femur.

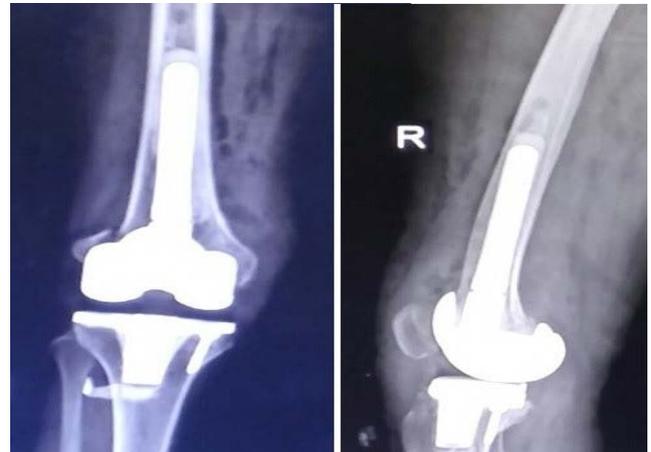
Figure 3. Postoperative radiographs after revision arthroplasty.

The patient underwent a revision arthroplasty using a stemmed femoral component retaining the tibial component polyethylene [Figure 3].

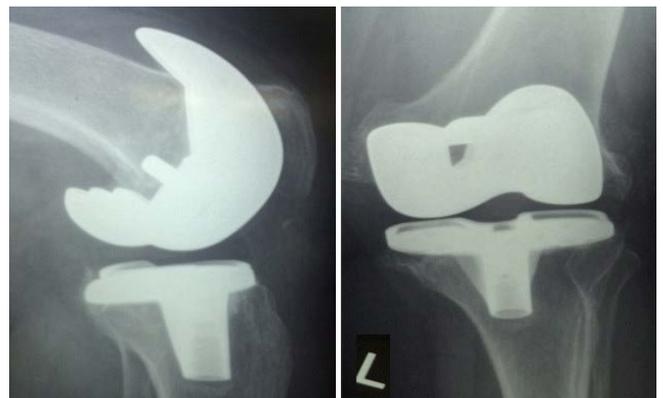
A 73-year-old woman, BMI=35, varus deformity of 30°, and stiffness in the left knee underwent primary TKA. She returned with lateral femoral condyle fracture after 8 weeks, and underwent a revision arthroplasty using, stemmed femoral and tibial components, constrained polyethylene and TM metaphyseal femoral cone [Figures 4; 5].

Figure 4. Post operative radiographs 8 weeks after primary TKA. Lateral femoral condylar stress fracture is notable.

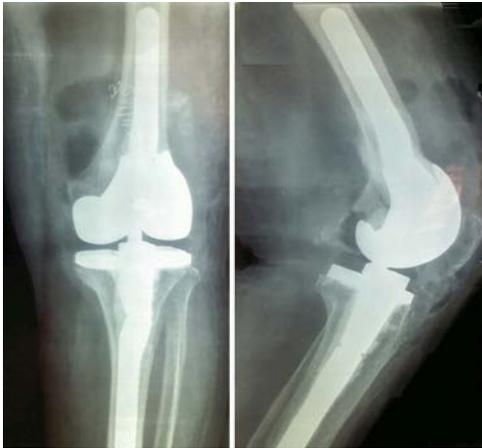
Figure 5. Post operative radiographs after revision arthroplasty.

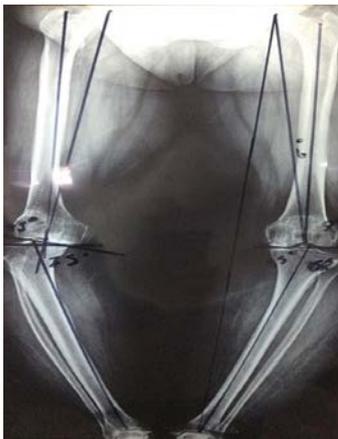
A 60-year-old woman, BMI=39, varus deformity of 25° with thrust on weight bearing underwent primary TKA [Figure 6]. She returned with lateral femoral condyle fracture after 8 weeks, and underwent a revision arthroplasty using, stemmed femoral and tibial components, constrained polyethylene and TM

Figure 6. A 60-year-old female with 25 degrees of left knee varus deformity and thrust.

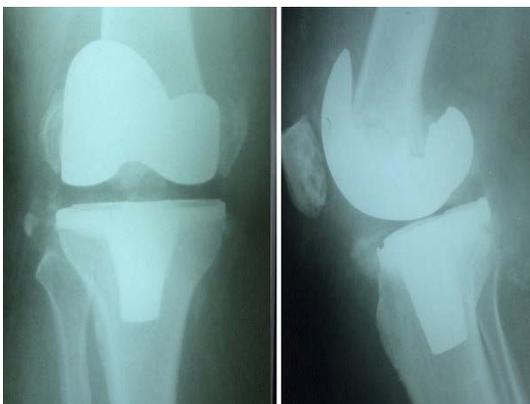
Figure 7. Lateral and anteroposterior views showing bicondylar femoral stress fracture 8 weeks after primary TKA.

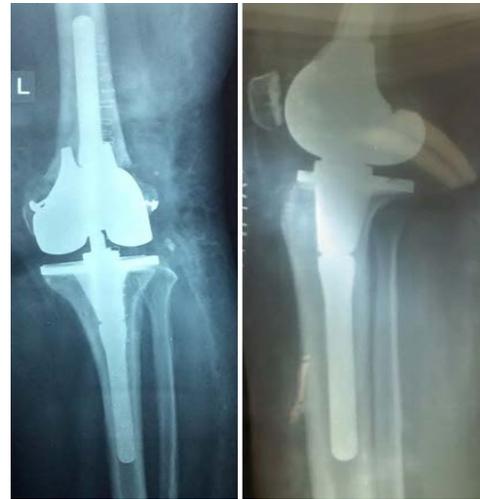
Figure 8. Post operative radiographs after revision arthroplasty using a constrained prosthesis and metaphysial cone.

metaphysial femoral cone [Figures 7; 8].
