**LETTER TO THE EDITOR****Intrapelvic Protrusion of a Broken Guide Wire Fragment during Fixation of a Femoral Neck Fracture**

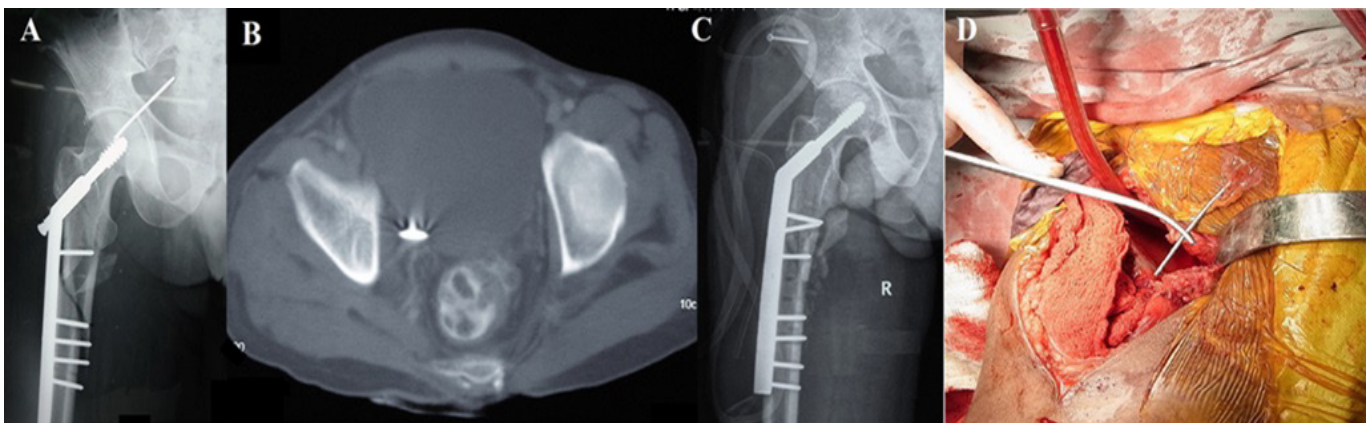
Figure 1A-D. (A) Antero-posterior radiograph of hip and proximal femur showing broken transfixing guidewire (B) Computed tomography scan of pelvis axial section showing guidewire tip exiting from quadrilateral plate (C) Postoperative radiograph of hip and proximal femur after removal of guidewire from hip joint showing iliac bone osteotomy fixed with screw (D) Intra operative clinical photograph of the surgical site showing the exposure with broken guidewire.

A 32-year old male was referred to us for broken guide wire removal from the hip joint. He had sustained right-sided sub-trochanteric femur fracture after a road-side accident. While he was undergoing fracture fixation at a local hospital dynamic hip screw (DHS) guide wire broke and migrated into the pelvis transfixing the hip joint. On presentation to our hospital radiograph [Figure 1A] and

computed tomography (CT) scan [Figure 1B] of the hip joint done and confirmed the exact position and point of exit of the guide wire. We used the aforementioned iliofemoral approach [Figure 1D]. Iliac blade osteotomy was done starting from the summit of the iliac crest to midway between anterior superior iliac spine and anterior inferior iliac spine along with attached tensor fascia lata muscle. As the wire was very deep in the pelvis, this approach allowed good exposure and manipulation under direct vision and minimised the chances of injury to intra pelvic contents. Wire was removed in one piece without any complications [Figure 1C].

In the index case, the iliofemoral approach with iliac blade osteotomy provided an excellent exposure and space to manipulate the wire exiting from the quadrilateral plate even though it was deep inside the pelvis.
