CASE REPORT

Modular Well-Fixed Hip Revision Stem Fracture: A Case Report and Literature Review

Fabio Pessina, MD; Carlo Cazzaniga, MD; Beatrice Manzini, MD; Carlo Cardile, MD

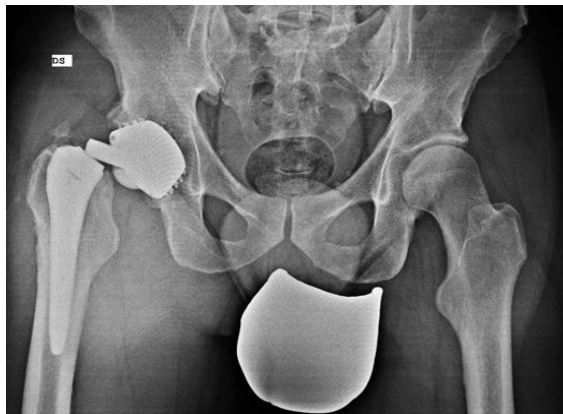
The initial prosthetic implantation was performed at another medical facility in 2006, and in 2011, the first fracture of the modular neck occurred, followed by the first

prosthesis revision also performed at another hospital [Figure 1, 2].

Figure 1. Preliminary X-rays of the first prosthetic modular neck fracture (2011)

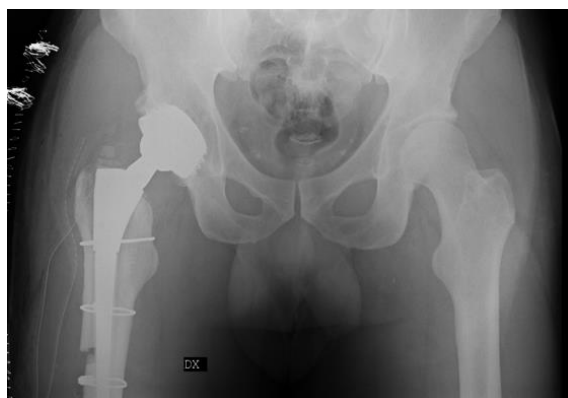
Figure 2. Post-operative X-rays of the first revision surgery (2011)

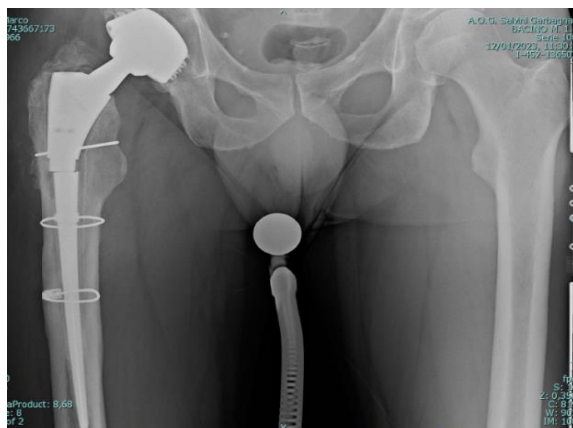
In January 2023, approximately one week following the onset of right hip pain without trauma, the patient presented to our emergency department where new X-rays were performed, revealing a fracture of the prosthetic stem [Figure 3].

Figure 3. Preliminary X-rays of the second prosthetic modular stem fracture (2023)

The preoperative planning involved a posterolateral approach, utilizing part of the previous surgical scar, and the revision of the prosthetic stem through extended trochanteric osteotomy (ETO).

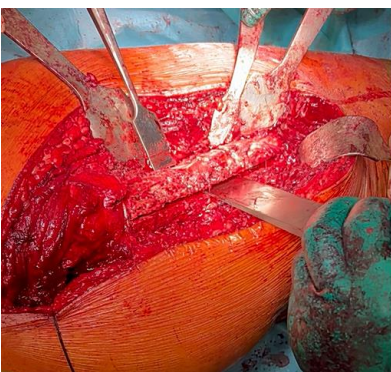
Figure 7. Intraoperative image: subtrochanteric osteotomy

mobilization. It was then manually extracted, preserving the trochanteric region intact [Figure 6]. Subsequently, with a safety cerclage placed below the planned osteotomy point, an extended sub-trochanteric osteotomy was performed from below the position of the first cerclage to the level of the isthmus. Sequential drilling was performed and subsequently joined by cutting with a blade along the posterior femoral region, laterally to the rough line, and the anterior femoral region [Figure 7]. After removing the bone flap, the prosthetic stem was exposed, detached, and extracted [Figure 8].

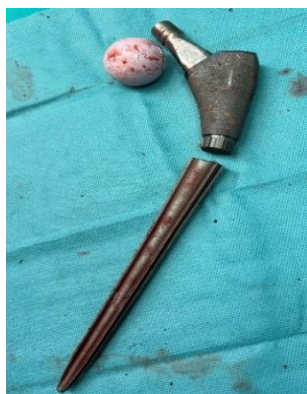
Figure 8. Intraoperative image: extraction of well-fixed stem

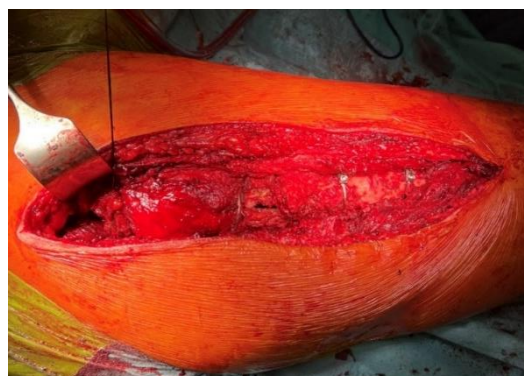
Figure 10. Intraoperative image: cable-ready cerclages

Following meticulous canal debridement and insertion of progressively larger broaches, a definitive uncemented stem was implanted with a lateralizing turret and ceramic head [Figure 9]. Finally, the bone flap was repositioned and fixed with 3 cable-ready cerclages [Figure 10].

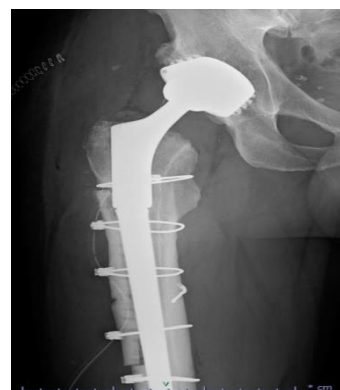
Figure 11. Post-operative x-rays: antero-posterior projection

After the surgery, postoperative follow-up X-rays were performed [Figure 11, 12].

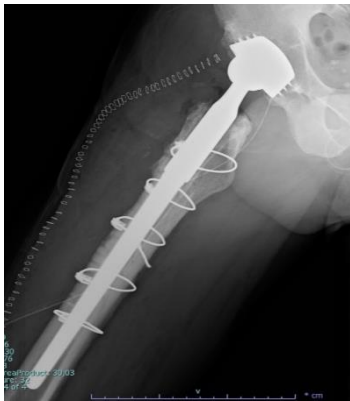
Figure 12. Post-operative X-rays: axial projection

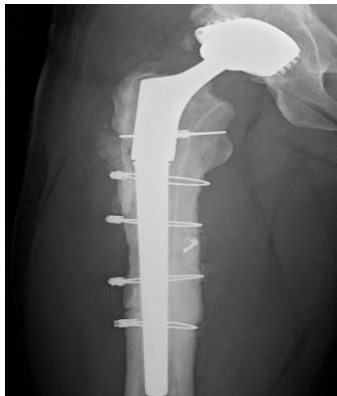
Figure 13. X-ray at 14 months: antero-posterior projection

At the last evaluation (14 months) no signs of complications were observed and the patient had an Harris Hip Score of 91, 5 [Figure 13-16].

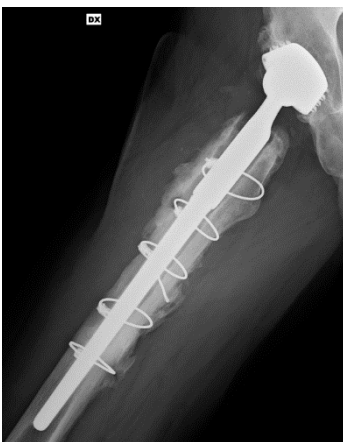
Figure 14. X-ray at 14 months: axial projection

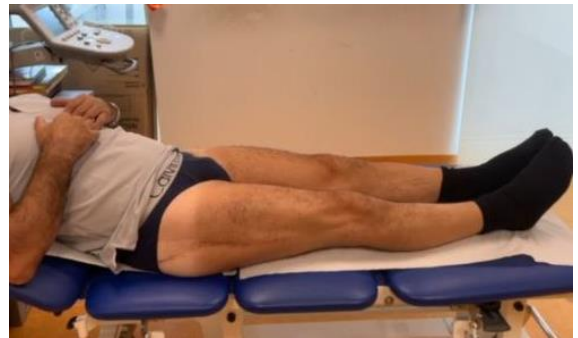
Figure 15. Clinical evaluation at 14 months: extension

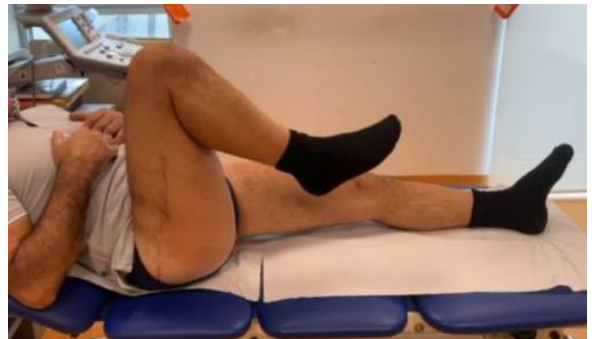
Figure 16. Clinical evaluation at 14 months: flexion
